SR 1/Thompsonville Interchange Kent County, Delaware

Wetland Overview

April 8, 2004

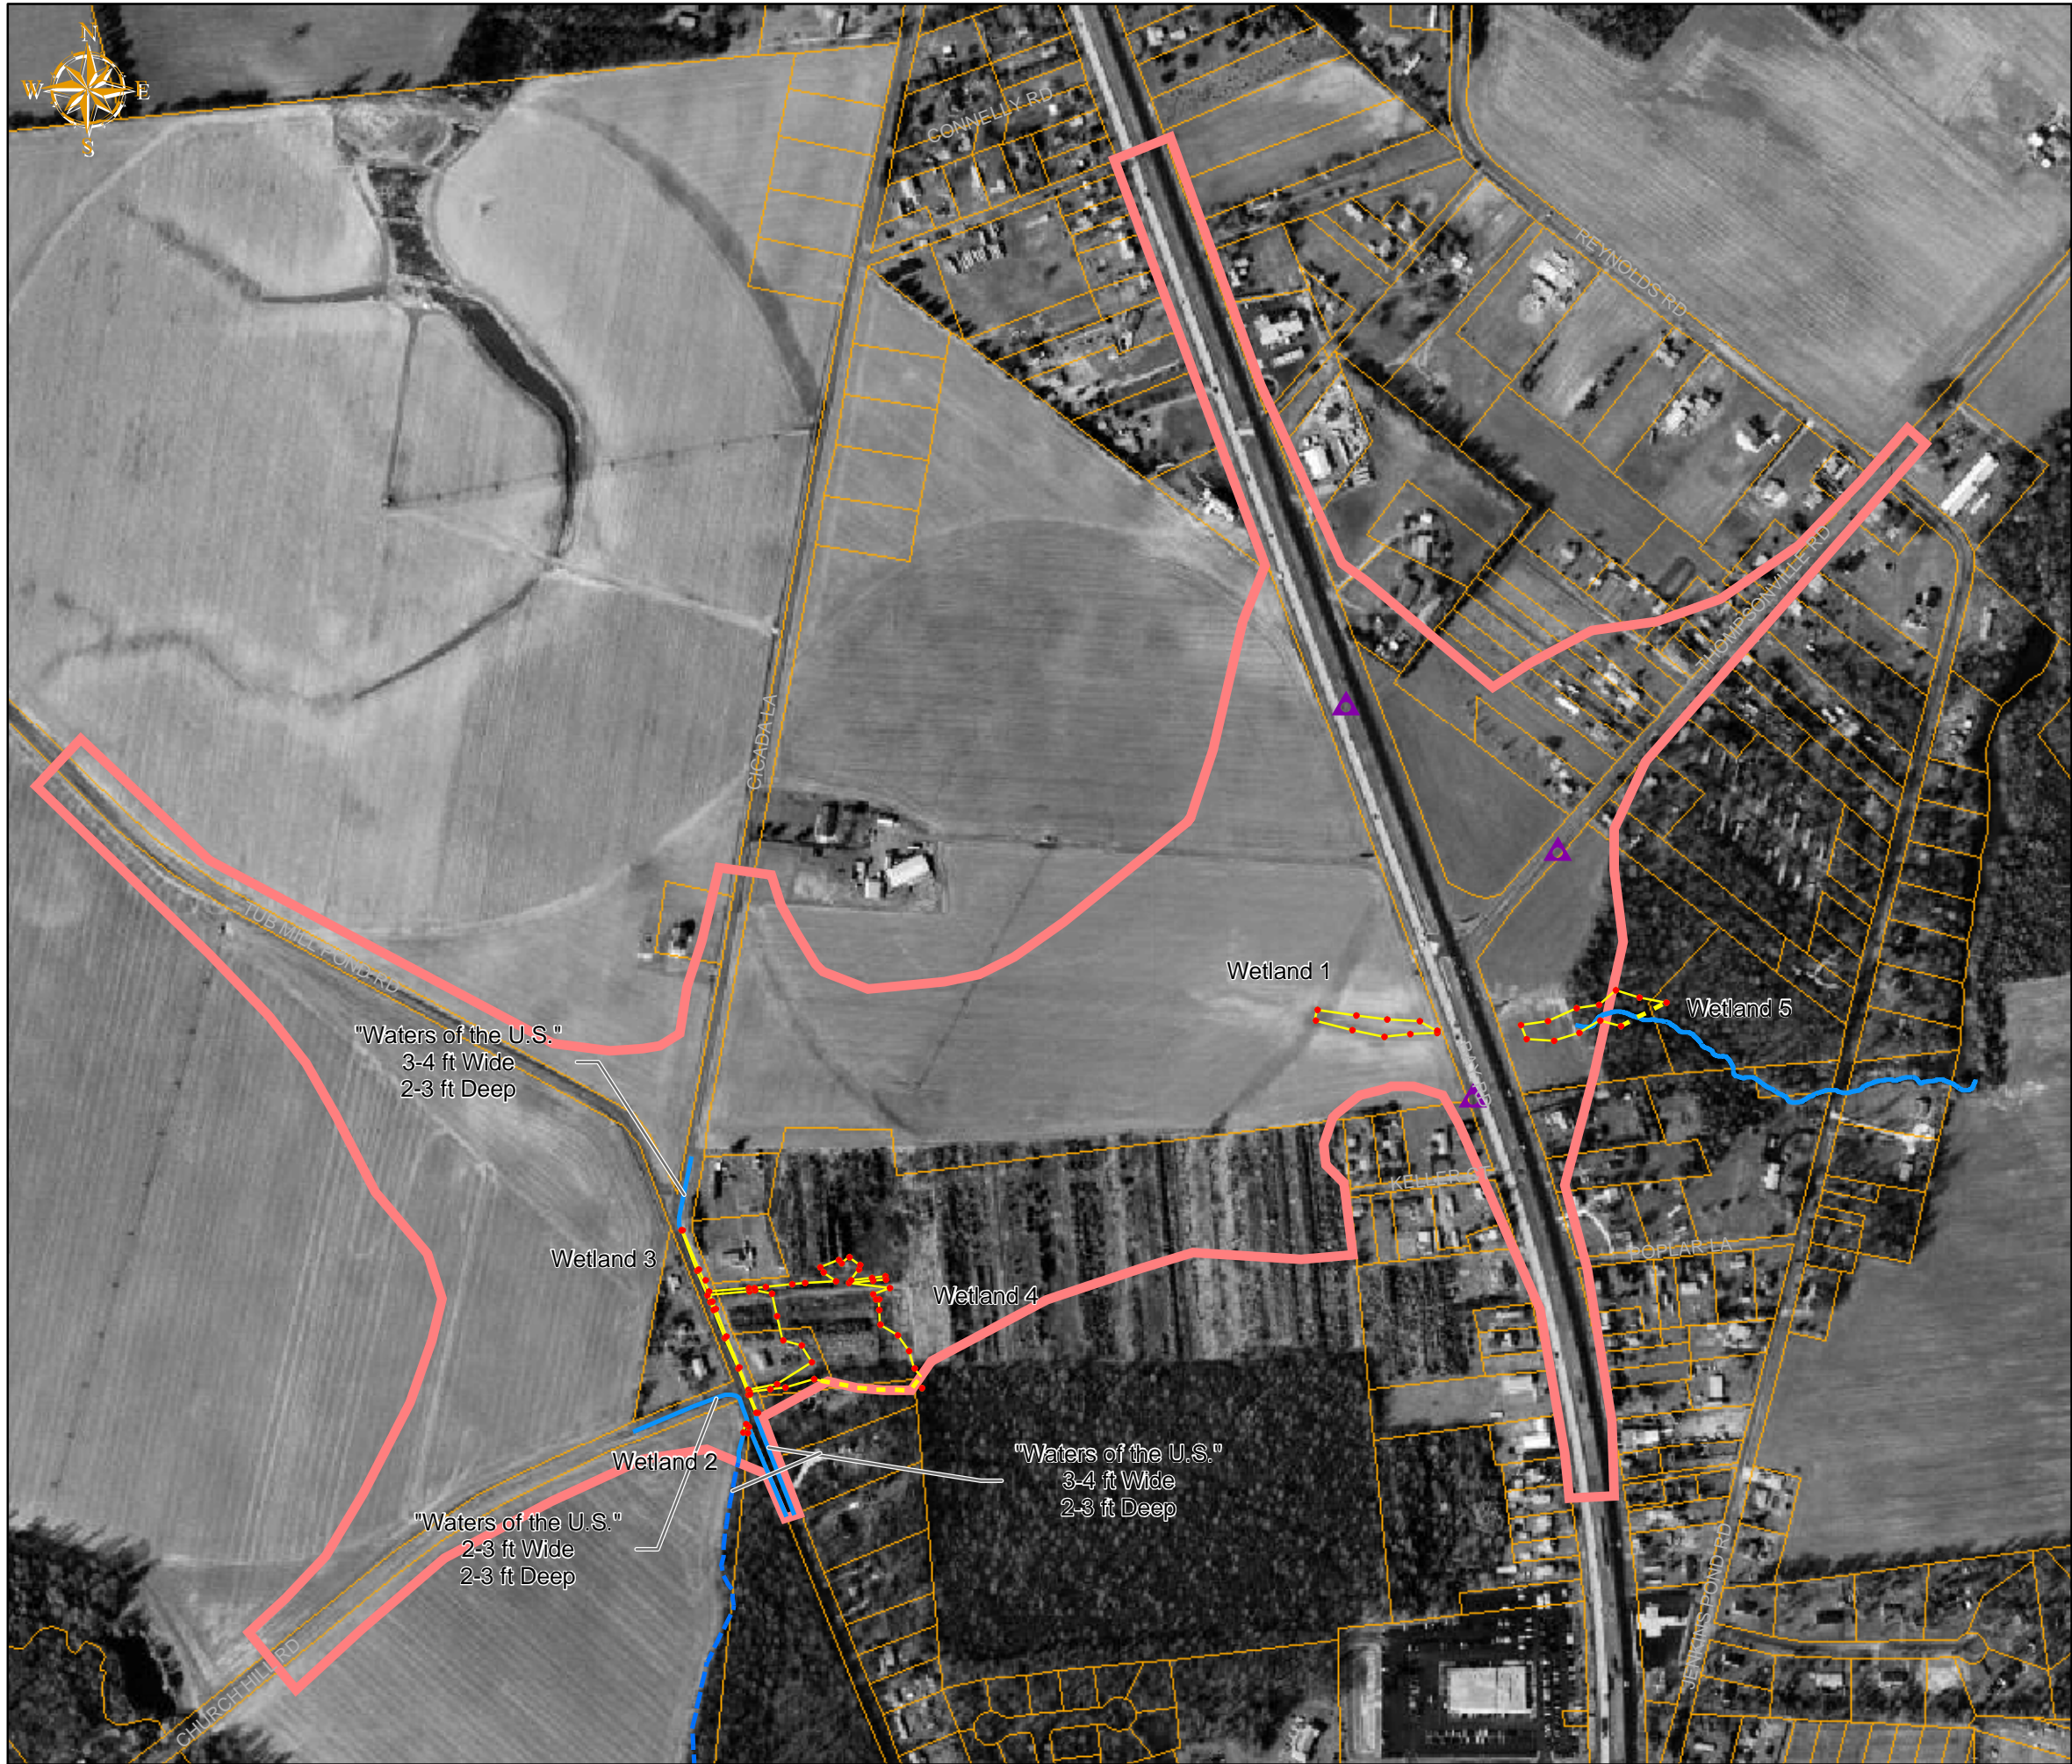
Note: There are non-federally regulated waters of the U.S. (i.e. swales/ditches) along all the roadways within the study area. The sections of these roadside ditches which are federally regulated are indicated on the plans. The non-federally regulated waters of the U.S. sections are comprised of swales with no obvious indications of a high water mark.

Sources:
1999 Aerial Photography
Century Engineering
Kent County, Delaware
A.D. Marble Site Investigation
